Evaluation Report No. E2079A Printed: July, 1980 Tested at: Lethbridge ISSN 0383-3445

Evaluation Report 176

Spierco M80 Fertilizer Attachment

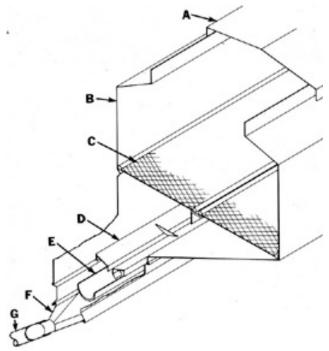
FIGURE 1. Spierco M80: (A) Lid, (B) Box, (C) Diamond Mesh Screen, (D) Baffle, (E) Oscillator, (F) Spout, (G) Delivery Tube.

An oscillating trough in the box bottom meters fertilizer through plastic discharge tubes to the grain box seed cups. Application rate is set by adjusting trough oscillation stroke.

FIGURE 1 shows a schematic view of the Spierco M80 while detailed specifications are given in APPENDIX I.
